Fatal accident in the Wernberg-Köblitz steel warehouse

Broken calf bone while hoisting new insulator

Cable drum rolls down slope

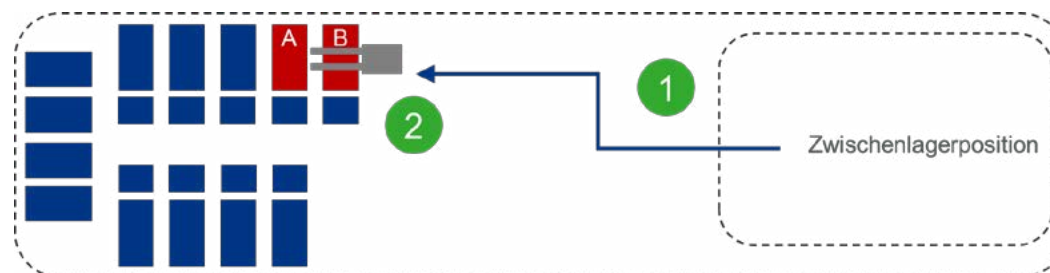
The two employees had been tasked with relocating various steel parts in the steel store from the offloading area to their final position. A wheel loader (Volvo L90E) with a fork attached was on hand for transporting the steel parts and depositing them on stacks. During the step of depositing a bundle with six (6) crossbeam rails with a total weight of

approx. 430 kg and length 5 meter, from the interim storage position (1) to the final storage position (2) on Stack A (height approx. 1.8 m), the bundle was lifted over Stack B, which was stored in front (see sketch). As Stack B was positioned in front, the wheel loader was unable to position the load directly above Stack A. A decision was taken in response to the situation to push the bundle by hand from the forks onto Stack A.

and was fatally injured have yet to be cleared up during the course of the accident investigation. The position of the fatally injured employee was between Stacks A and B.

- Before starting work, danger zones must be identified and clearly marked;
- In the event of changes to the planned workflow or with unclear and/or potentially unsafe situations: STOP the work, discuss and assess the situation (LMRA);
- Consult with your supervisor where the work no longer corresponds to the workflows evaluated and protective measures stipulated in the risk assessment;
- Lift and deposit construction components only when the load to be deposited is directly above the intended location;
- Do not push or lift loads from forklifts unless the forks are close to the ground;

- Review of warehousing concepts and risk assessments for storing construction components and removing them from storage;
- Instruct employees in the measures;
- Until the abovementioned measures are implemented, work of this nature in steel stores of this description will not be carried out for the present by TenneT personnel. This does not apply to general loading work in other stores and areas.

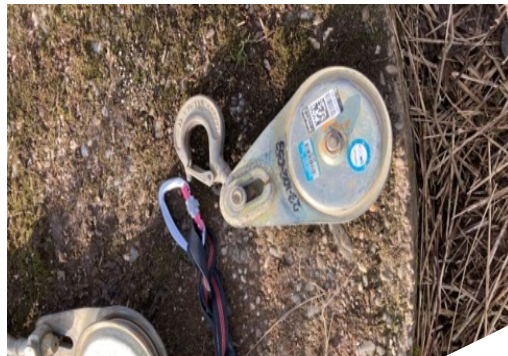
On Saturday, 12 February a technician broke his calf bone while hoisting a new insulator into a power pylon at the Diemen - Lelystad Black line. To enable the chains to be lifted up, a hoisting belt was used to suspend a pulley from a cross beam of the power pylon. The tackle rope was pulled through the pulley. The hoisting belt shot loose during the hoisting operation, causing the pulley to come undone as well. The forces this exerted in turn broke the tackle rope.

The bucket of the hydraulic platform was located near the pulley's suspension point and contained two of the contractor's technicians and the hydraulic platform's operator. As the tackle rope broke loose, it hit the calf bone of one of the technicians, causing a break.

- The pulley was not properly attached to the cross beam;
- The hydraulic platform's bucket was improperly positioned;
- No LMRA was performed prior to doing the work;
- The 'danger zone' was not clearly identified. When something goes wrong, it releases energy.

- Assemble the parts the right way and have this checked;
- Position the hydraulic platform's bucket outside the danger zone;
- Always carry out an LMRA before doing any work.

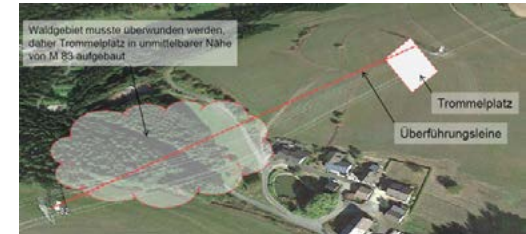
A deflection pulley was attached to a new, full cable drum at the drum site. The transfer line was threaded through this pulley and attached to a motor vehicle.

1. Deflection pulley is attached to the cable drum, transfer line attached to vehicle..

- Knowledge and information about “anchor and deviation points” are essential to working safely. Only when these details are known can they be assessed (risk assessment) and communicated (operating instructions, work instructions, work sequence description, training, instruction, construction start-up meeting, etc.)

- Work preparation must also include the provision of suitable tools and verification of their condition
- The work procedure should be scrutinised by all parties involved:
- Is all the necessary information available? Information outside the work task itself is sometimes useful (e.g. next work steps planned for subsequent days).
- Was the provided information understood?
- Any lack of clarity must give rise to further consultation (e.g. with the customer)

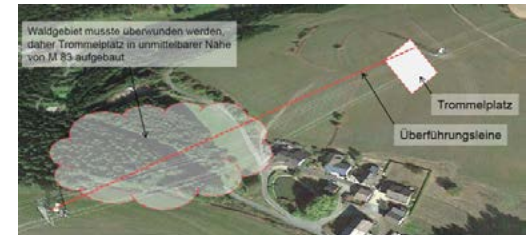
The vehicle started to move, causing the drum to twist and roll down the slope until it was stopped by trees. There was resulting property damage.

2. Vehicle moves, pulls transfer line, which rotated the drum.

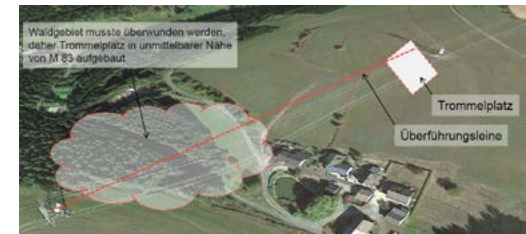
- Selection of unsuitable anchor/deflection points that cannot statically/dynamically bear the loads
- Heavy loads (e.g. steel drums, ballast weights) are considered to have a high holding effect without taking account of their geometry or existing coefficients of friction (e.g. steel on steel).
- Aids used to prevent objects from rolling away are not always selected with the necessary care (e.g. rotten squared timbers).
- The risk assessment (or documents based on it) often does not describe anchor and deviation points in the detail necessary for practice.
- Work preparation and work instructions often do not cover all the required work equipment or its condition with regard to drum and machine positioning.

3. Drum rolls down the slope, direction pylon 71 and is stopped by trees in wooded area.
